TECH BULLETIN

Drum & Pail “Paneling”

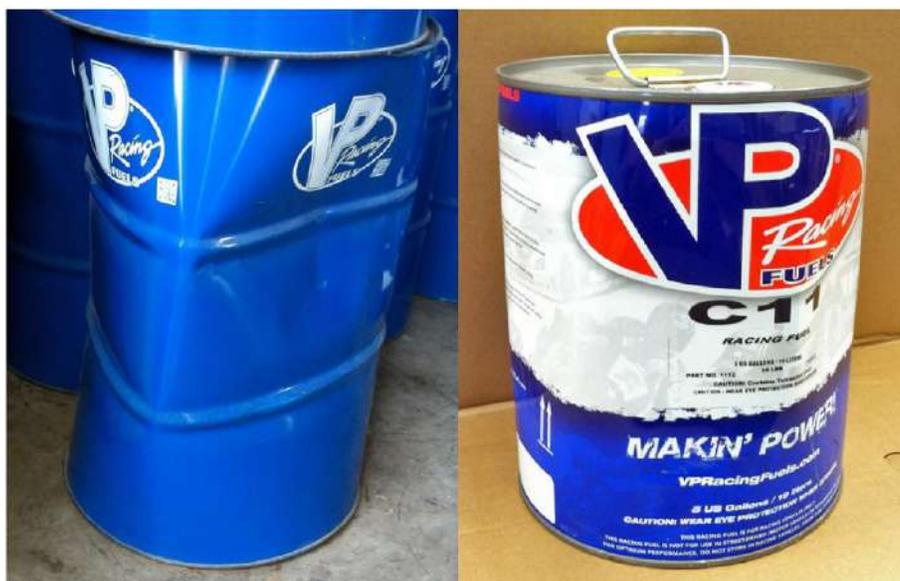
This tech bulletin is to bring awareness to our customers of an issue called “paneling.” Paneling can occur in most steel or aluminum packages (including VP’s 1 gallon can, 5-gallon pail and 54-gallon drum). Paneling occurs when there is a variance in temperature, hot to cold, from when the product is packaged to when it is delivered to its destination. Most of VP’s products are packaged in Texas. If the product is shipped to a climate that is 30-40° lower than when the product was packaged, the internal vacuum created from this temperature change can result in the sides of the container bowing inward, which is known as paneling. See photos below for examples of what paneling looks like.

Paneling is not a packaging defect and is a sign of a well-sealed container. Unfortunately, paneling cannot be prevented. These products are not defective or damaged in transit. Despite the look of the packaging below, the integrity of the product contents inside has not been compromised. The packaging itself, although not in its original shape or form, did its job by staying airtight and not leaking.

The results of paneling are a direct effect of atmospheric changes. Because the product was not “damaged” by VP or the shipper, the manufacturer/shipper is not responsible for replacing product affected by paneling. The products are not damaged or defective goods and are suitable for the intended purpose.
